SEA GRAPE TRIMMING AND SEA TURTLES

SEA GRAPE TRIMMING GUIDELINES

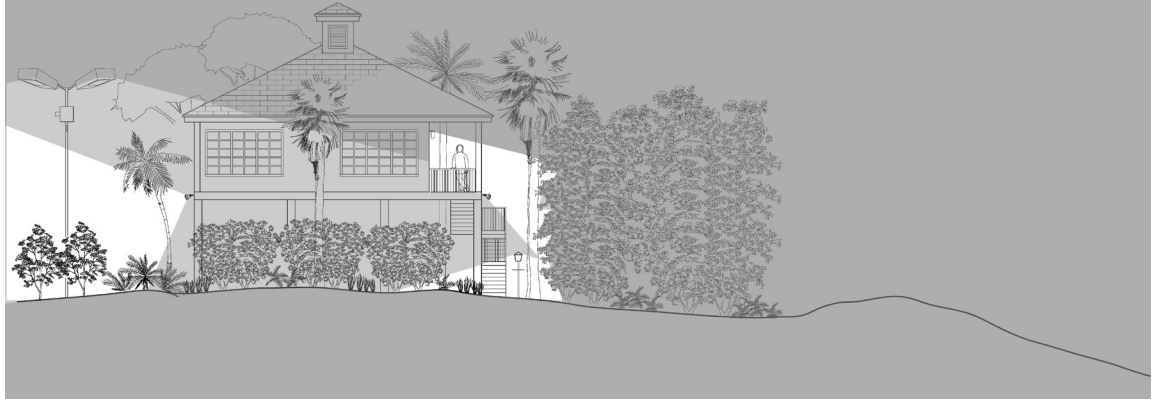
BEFORE
SEA GRAPE
TRIMMING

This diagram depicts a beach house with several styles of exterior lighting. These lights are shielded from the beach by a large stand of sea grape, *Coccoloba uvifera*. The homeowner would like to trim this stand of sea grape to improve the

view from the balcony but is concerned about light trespass onto a sea turtle nesting beach and potential liability should these lights cause the disorientation and deaths of protected sea turtles.

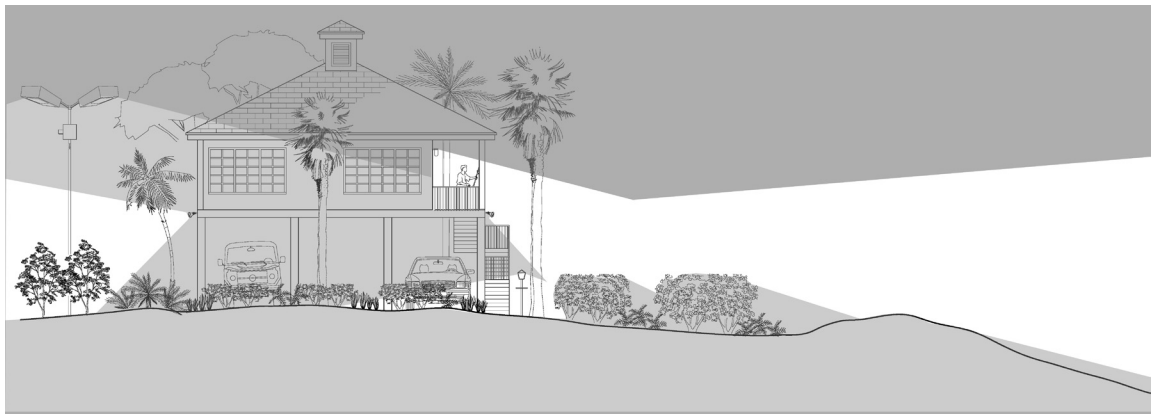
BAD
SEA GRAPE
TRIMMING

Here, the homeowner has over trimmed the sea grape stand. Although the homeowner now has a better view of the ocean, light pollution now shines onto the nesting beach disrupting normal sea turtle nesting behavior. Of particular concern are the poor light fixtures, car headlights and now the streetlight

are also visible from the beach. This unpermitted trimming damages the sea grape stand, disrupts sea turtle nesting and exposes the homeowner to potential legal action including substantial fines.

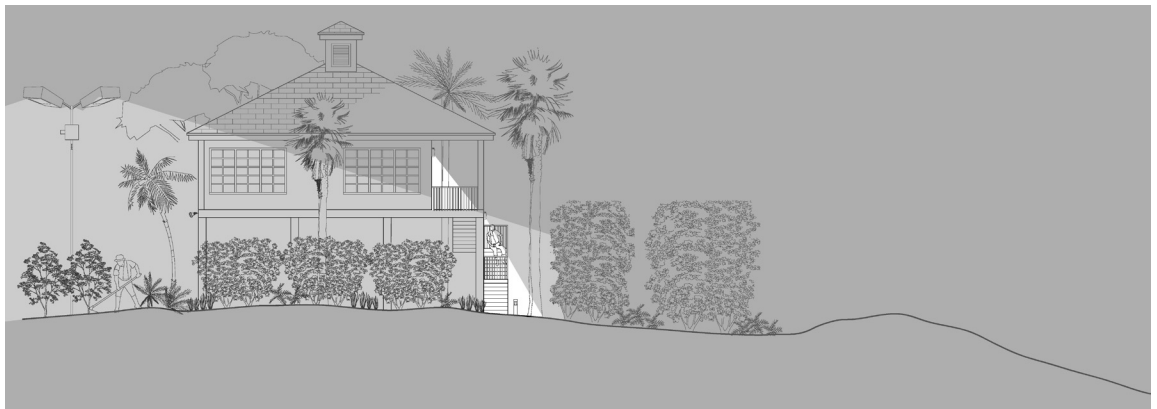
APPROPRIATE
SEA GRAPE
TRIMMING

The trimmed seagrape stand now allows a view of the ocean from the balcony. Realizing this would make the balcony light visible from the beach, the homeowner has replaced the jelly-jar light with well shielded canister downlight equipped with a FWC approved 3watt to 12watt Amber LED lamp. The

homeowner has also replaced the floodlight on the beachside of the house with another canister downlight and bollard fixture with downcast horizontal louvers to illuminate the stairs for safety. Even after trimming, the homeowner has actually reduced illumination visible to the nesting beach.

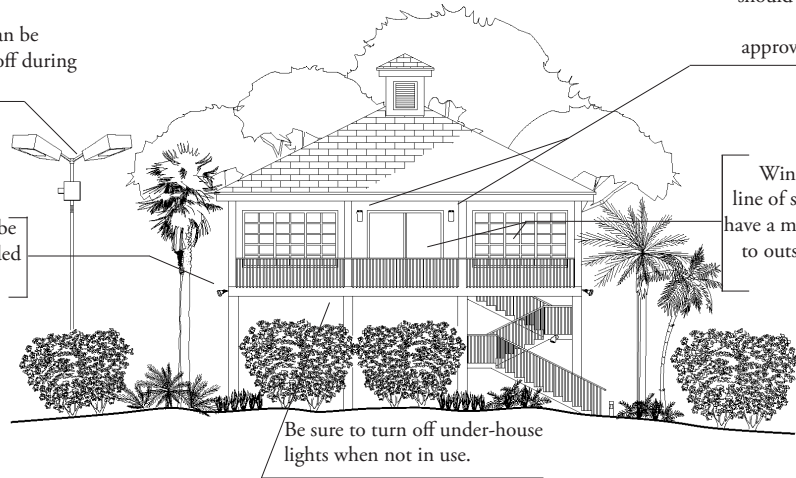
A TYPICAL BEACH HOUSE AS SEEN FROM THE OCEAN

Many streetlights can be shielded or turned off during nesting season.

Floodlights should be replaced with shielded downlights.

Unshielded balcony lights should be replaced by canister downlights with FWC approved Amber LED lamps.

Windows and doors within line of site of the beach should have a minimum of 45% inside to outside light transmittance window tinting.

Be sure to turn off under-house lights when not in use.

This diagram depicts a typical beach house with several styles of exterior light fixtures. These fixtures are inappropriate for use near sea turtle nesting beaches and should be replaced with shielded, downward directed lights. When correcting problem light fixtures, don't forget about your interior lights. Windows within line of site of the beach should

be tinted with 15% to 45% inside to outside light transmittance film. Try to make it a habit to keep your window blinds closed at night during sea turtle nesting season from May 1st through October 31st through most of the state and from March 1st through October 31st from Brevard through Broward County on the Atlantic coast.
